Date: January 14, 2016

Re: Timeline for Galileo Galilei Way Site Activities Reference

MEMORANDUM

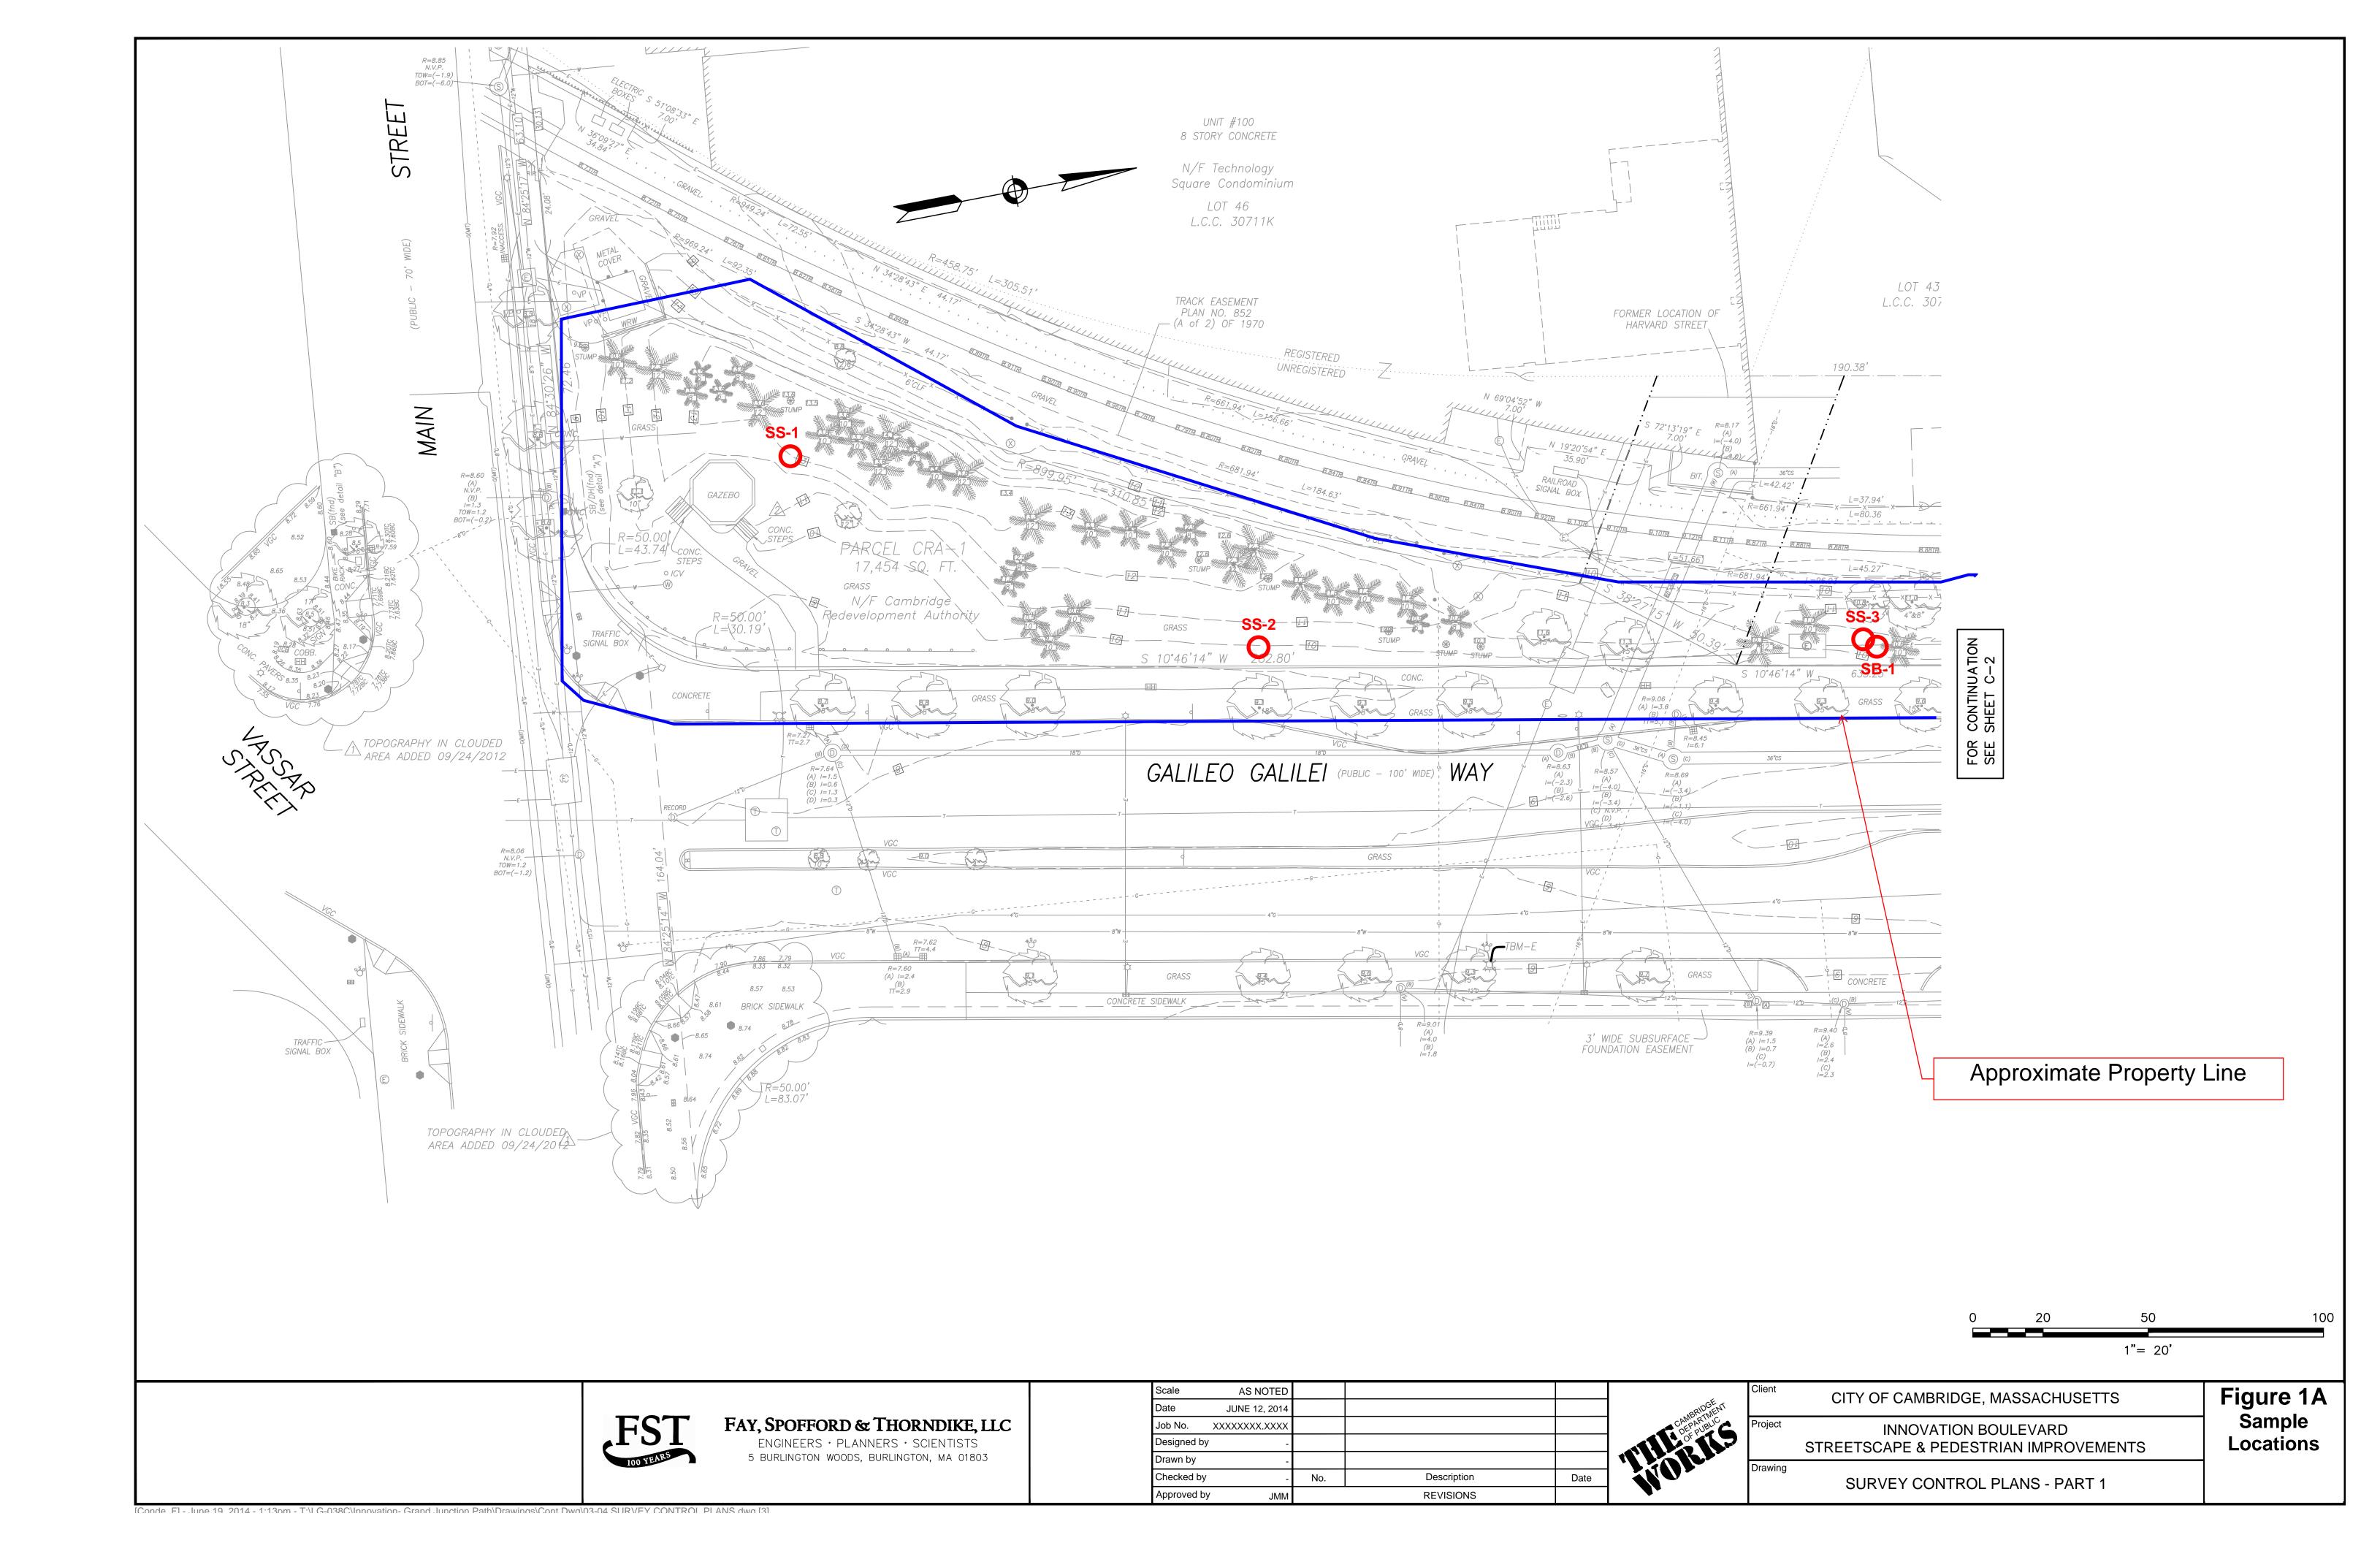
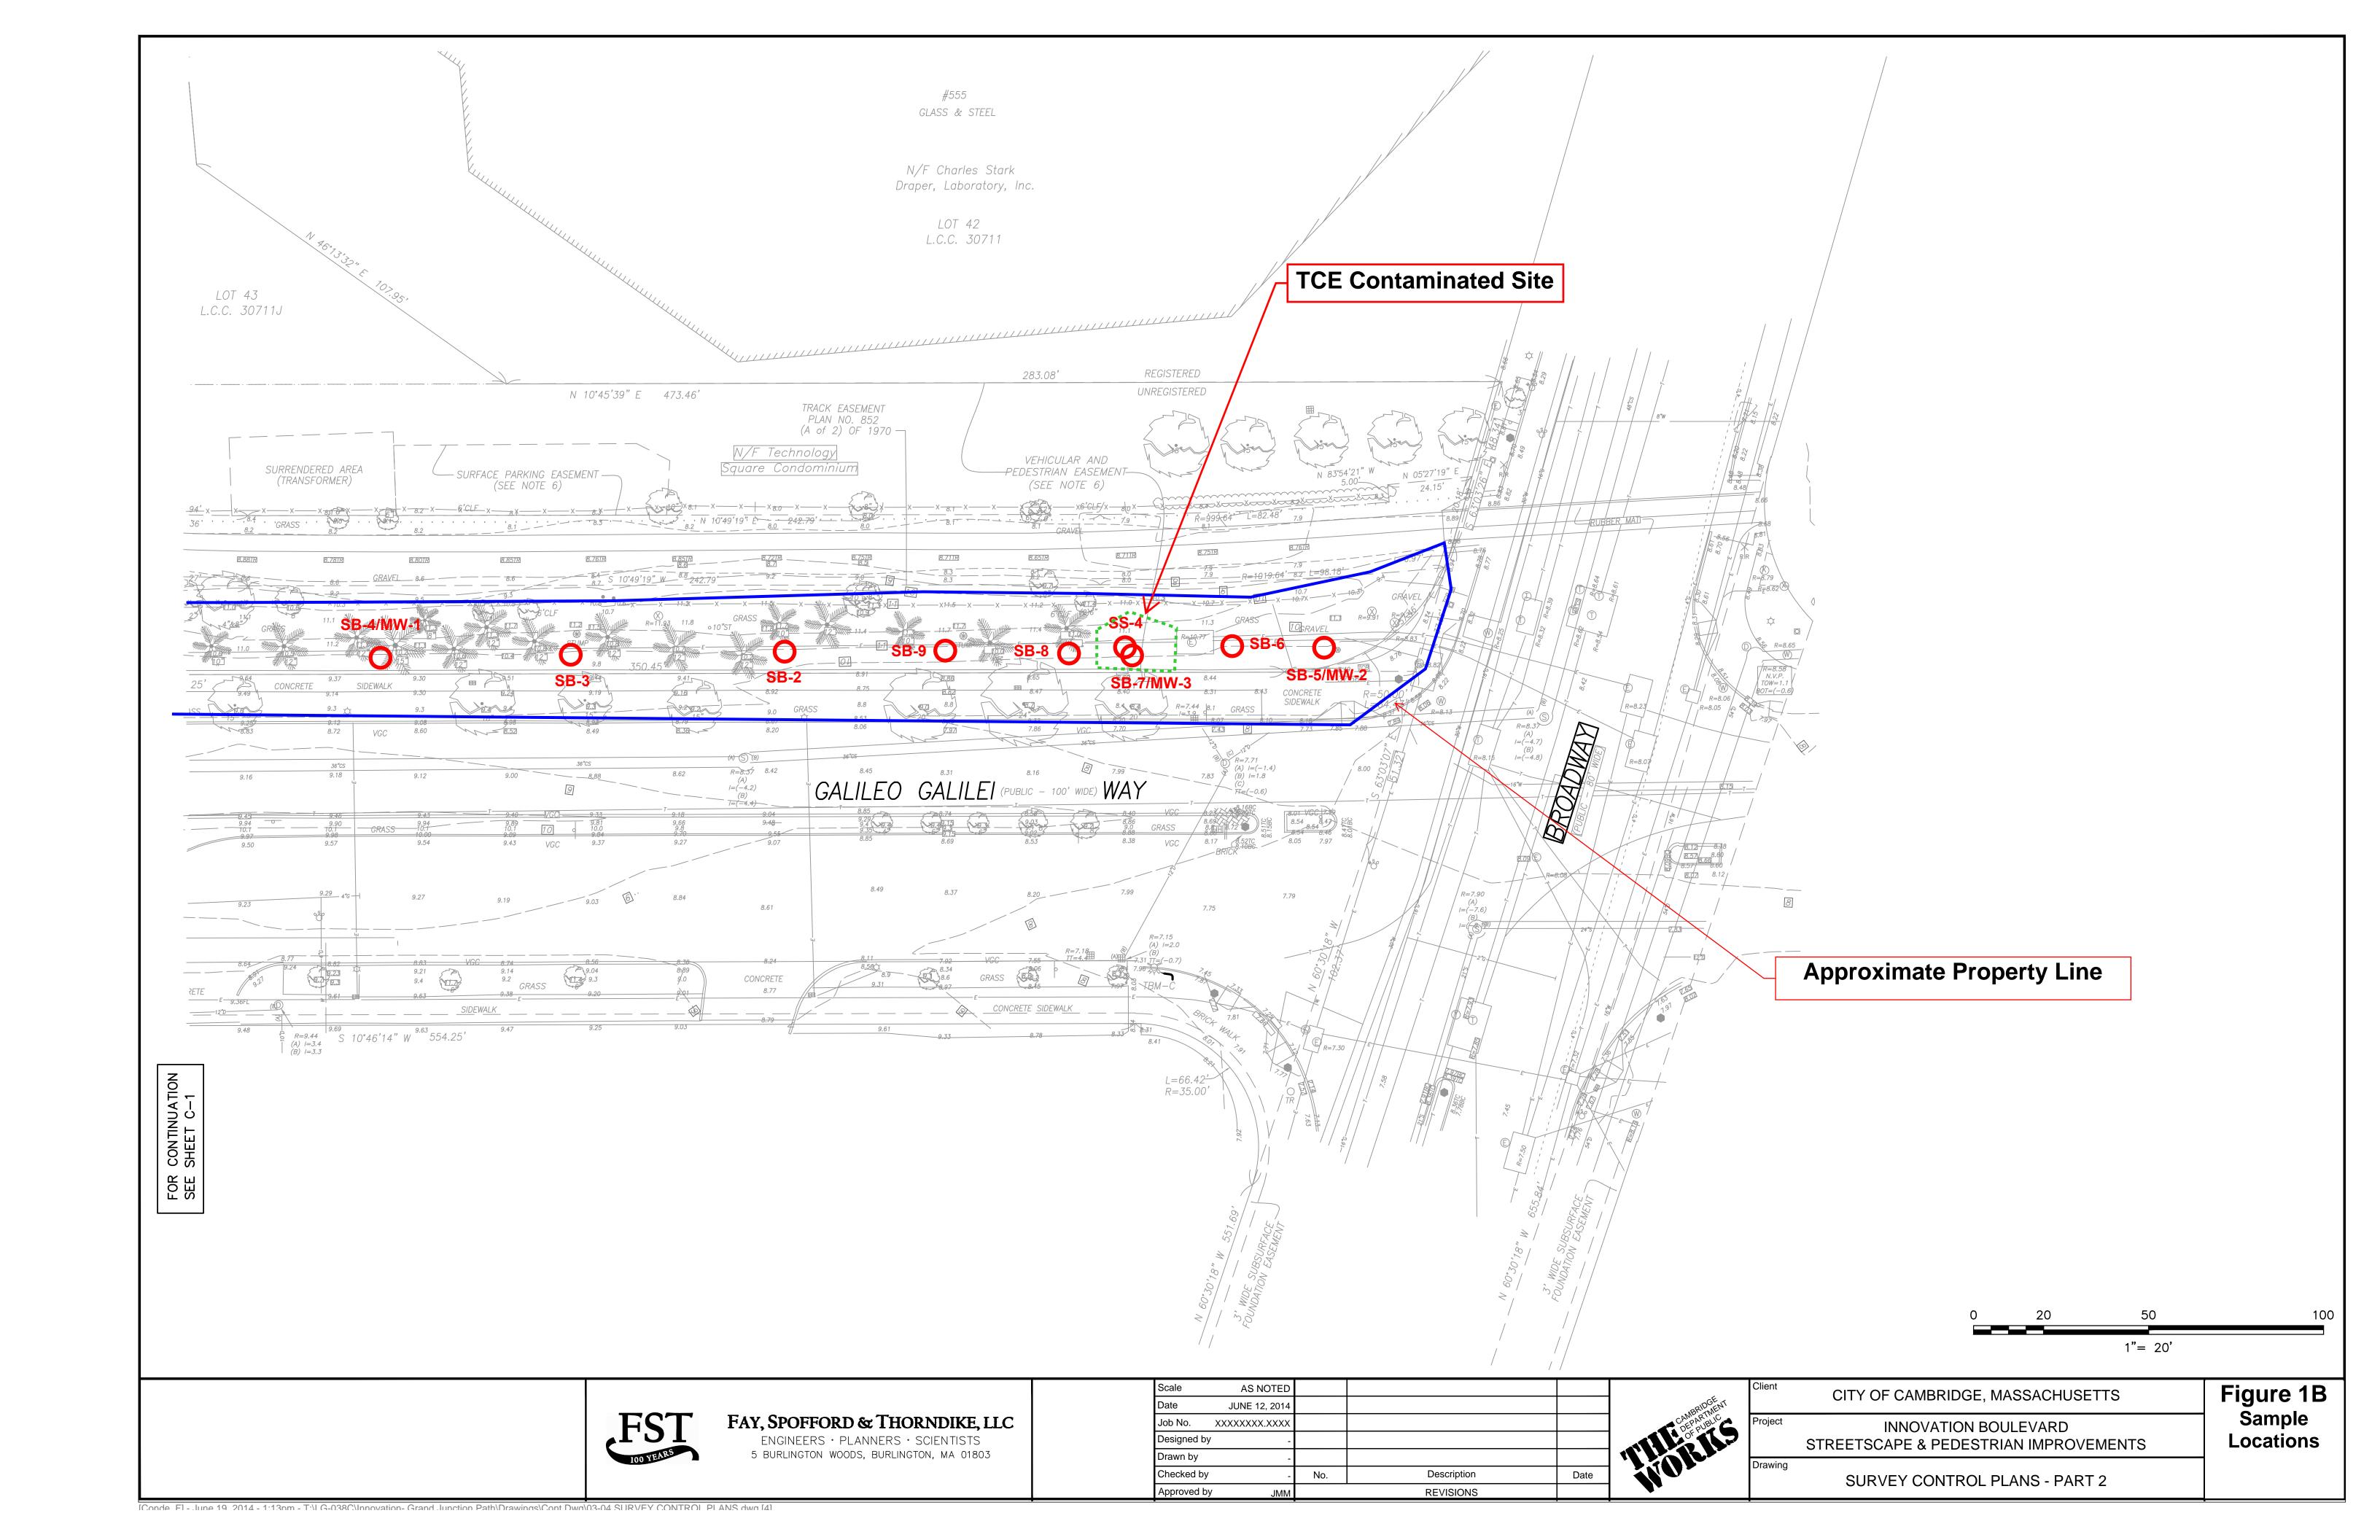
Attachment: Sample Locations Plan

Concerns were raised regarding the potential for contamination in the soil to be excavated for the proposed widening of this path and the consequent effect on reuse options for excess soil. Four shallow soil samples were collected alongside the pathway between Main Street and Broadway. The attached figure presents the sample locations. While some typical "urban fill" contaminants were detected, an unexpected TCE also was detected in samples 3 and 4 at concentrations of 0.153 and 24.1 mg/Kg (parts per million). The concentration in Sample 4 exceeds the DEP Reportable Concentration of 2 mg/Kg for this chemical. The Cambridge Redevelopment Authority (CRA) notified DEP as required.

The results of the soil testing confirmed the presence of TCE, albeit at low concentrations. Only two samples contained detectable concentrations of TCE and the highest concentration detected in this second round of sampling was 0.22 mg/Kg compared to the highest previous concentration of 24.1 mg/Kg. Boring SB-7 was taken very close to the location of the original sample with the high concentration. No TCE was detected in the three samples from this boring.

The sampling data indicates TCE contamination concentrated at one location. It was not found wide spread across the project length. This evaluation led to a decision to address the contamination during construction of the path. The agreed-upon approach was the excavation and disposal of the TCE-contaminated soil. Stantec, as CRA's LSP, would provide field inspection to determine limits of excavation and collect confirmatory samples post excavation. Provisions to implement this approach were included in the project's plans and specifications for inclusion in the bid package, and required submittals were sent to DEP.

The plan was implemented during construction. On September 11, 2015, the location of sample SS-4 was determined by the Stantec staff member who had taken the samples using field notes and memory. Stantec used visual, olfactory, and photoionization detector (PID) screening indications to monitor TCE-contaminated soil. Soil at this location was excavated by hand and placed in a drum. Excavation continued until the PID headspace screening of soils from the sides and bottom of the excavation were less than 1 ppmv. Stantec collected confirmatory soil samples along the sides and bottom of the excavation. The following table contains the analytical results. Concentrations in samples from the sidewall were below detection limits. The sample from the bottom of the excavation contained 0.067 mg/Kg of TCE. This concentration is significantly below the most-stringent DEP remediation soil standard of 0.30 mg/Kg. The detection, albeit at low concentration, supports our objective that the excavation occurred at the correct location.
